**EXPANDED SITE INSPECTION
of the
RT. 7 CHEMICAL DUMP (MD-75)/
NEW JERSEY FIREWORKS SITE**

MAY 2005

Prepared by: Maryland Department of the Environment
Waste Management Administration
1800 Washington Boulevard
Baltimore, MD 21230

Prepared for: U.S. Environmental Protection Agency
Region III
1650 Arch Street
Philadelphia, PA 19103-2029

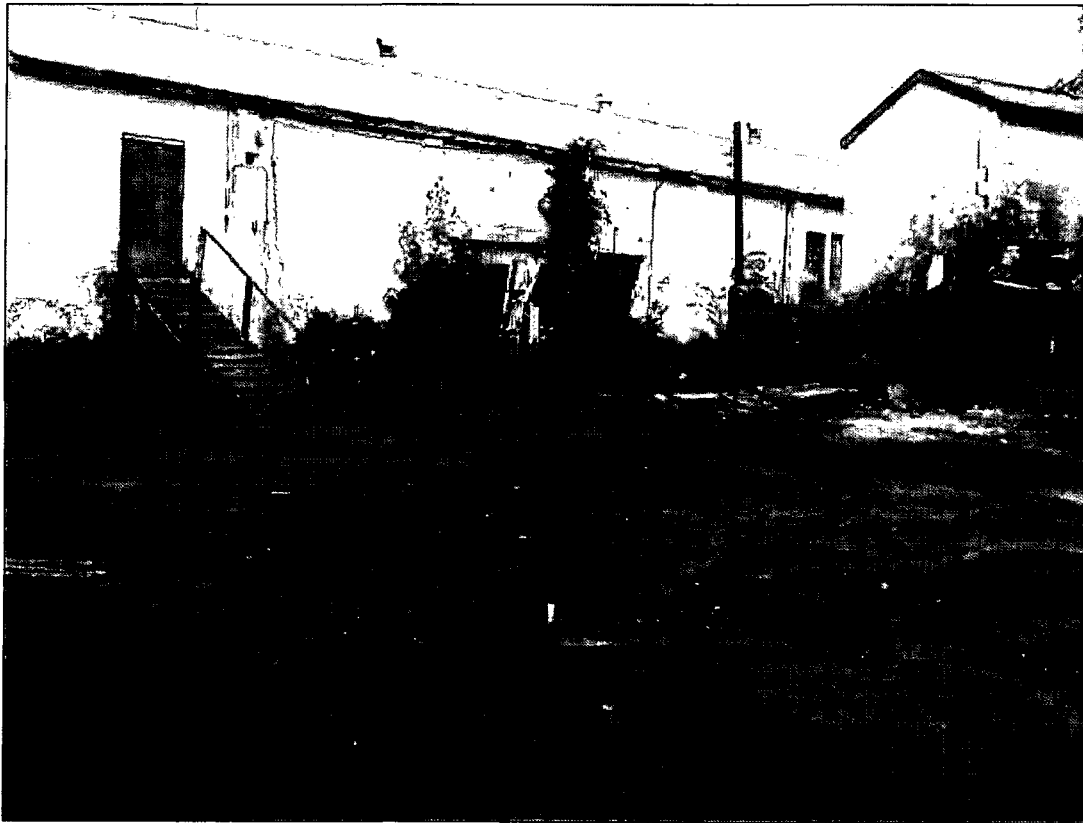
Photo of S-21/SS-21, SS-25 and GW-2 facing northwest towards the sparkler building.

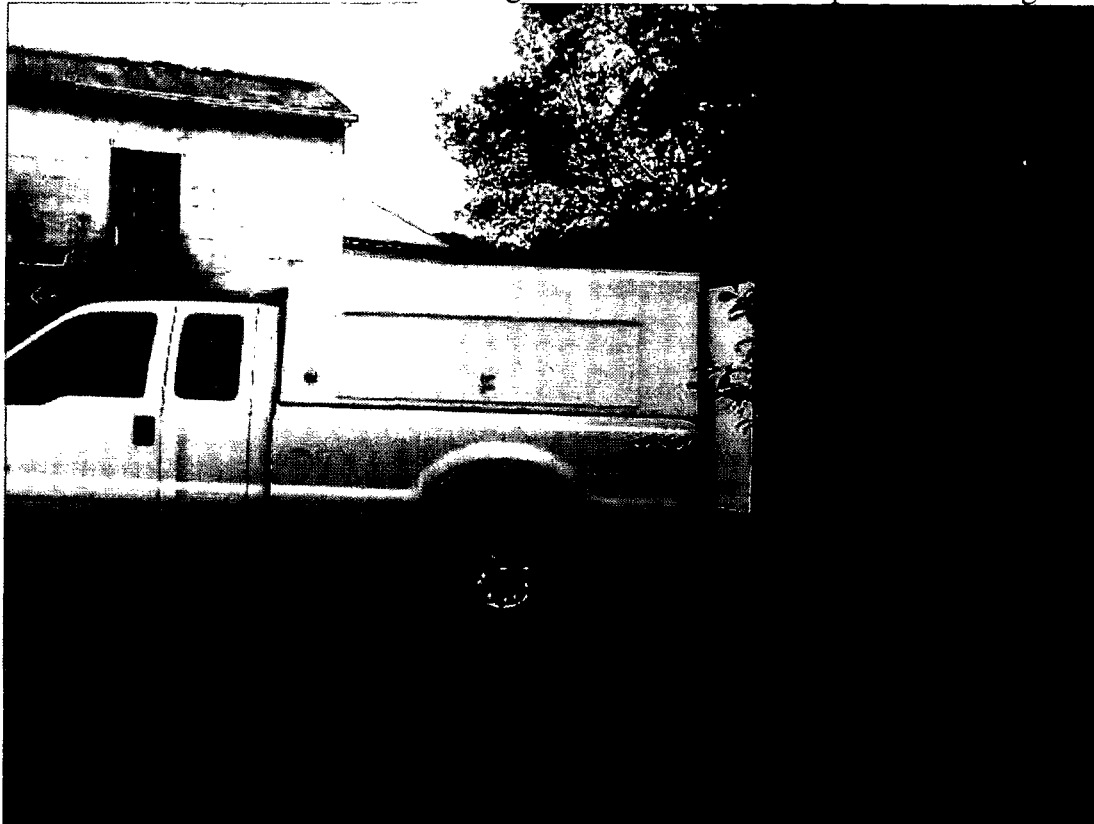
Photo of S-22/SS-22 facing west northwest towards the sparkler building.

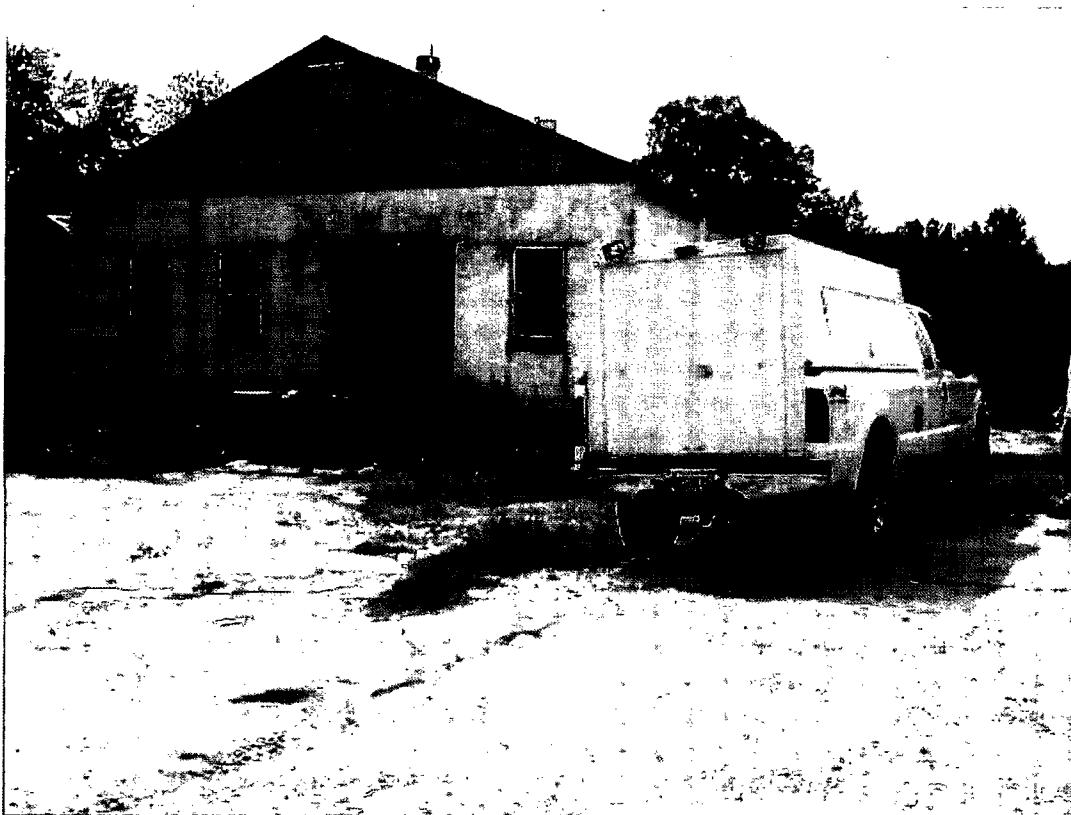
Photo of S-23/SS-23 facing southeast towards the sparkler building.

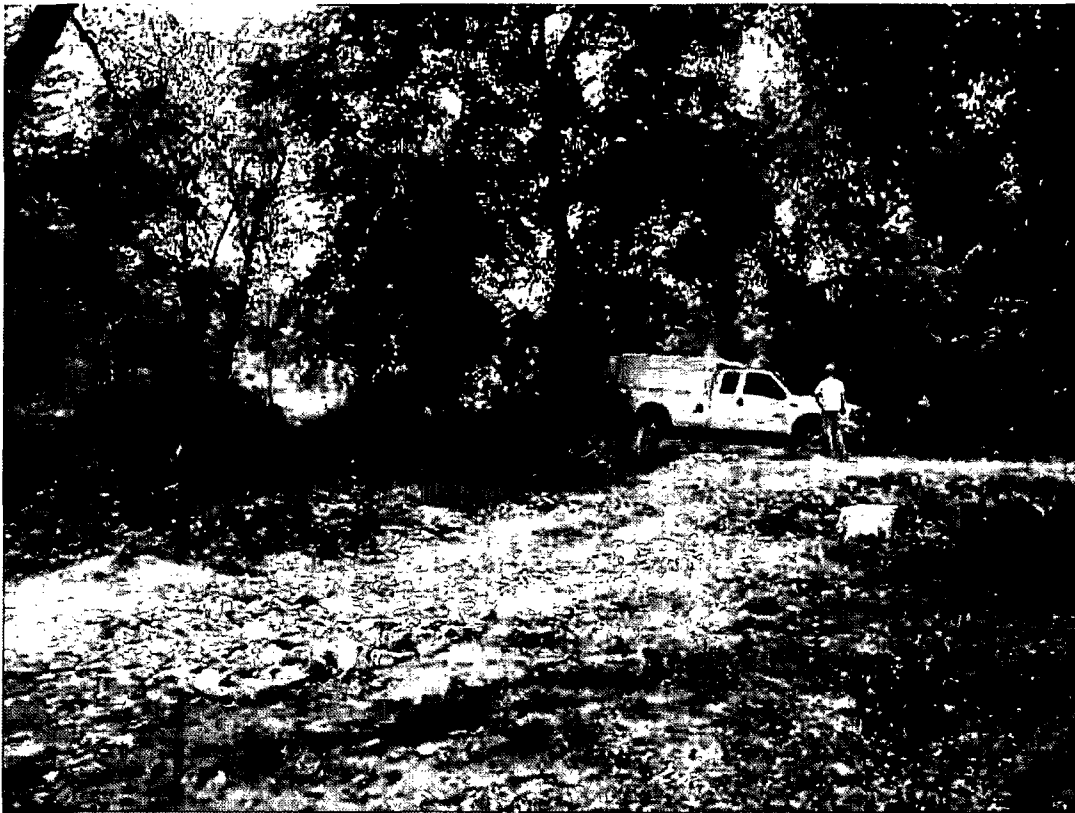
Photo of S-11/SS-11, S-15 (duplicate of S-11) and GW-1 facing northwest toward Rt. 7 Dump.

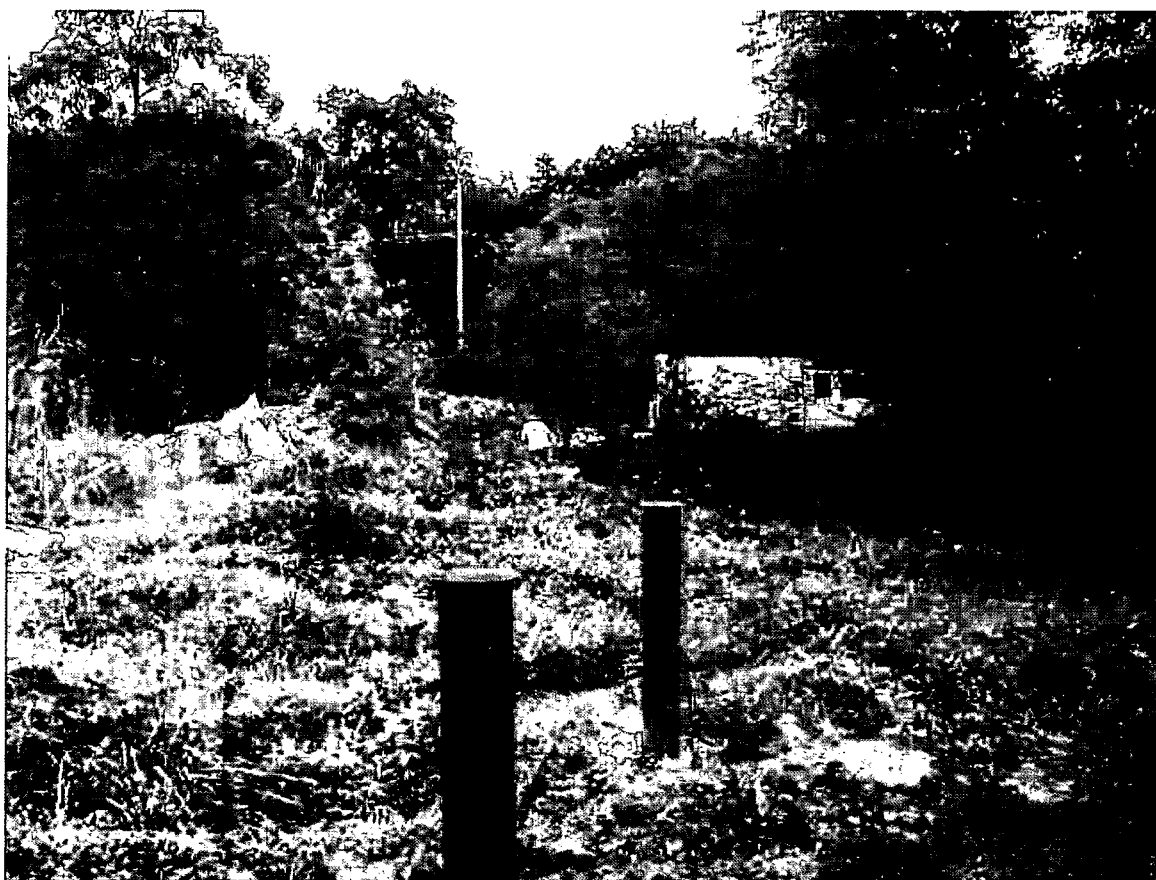
Photo of S-13/SS-13 and monitoring wells MW-1/1A facing north near the Rt.7 Dump.

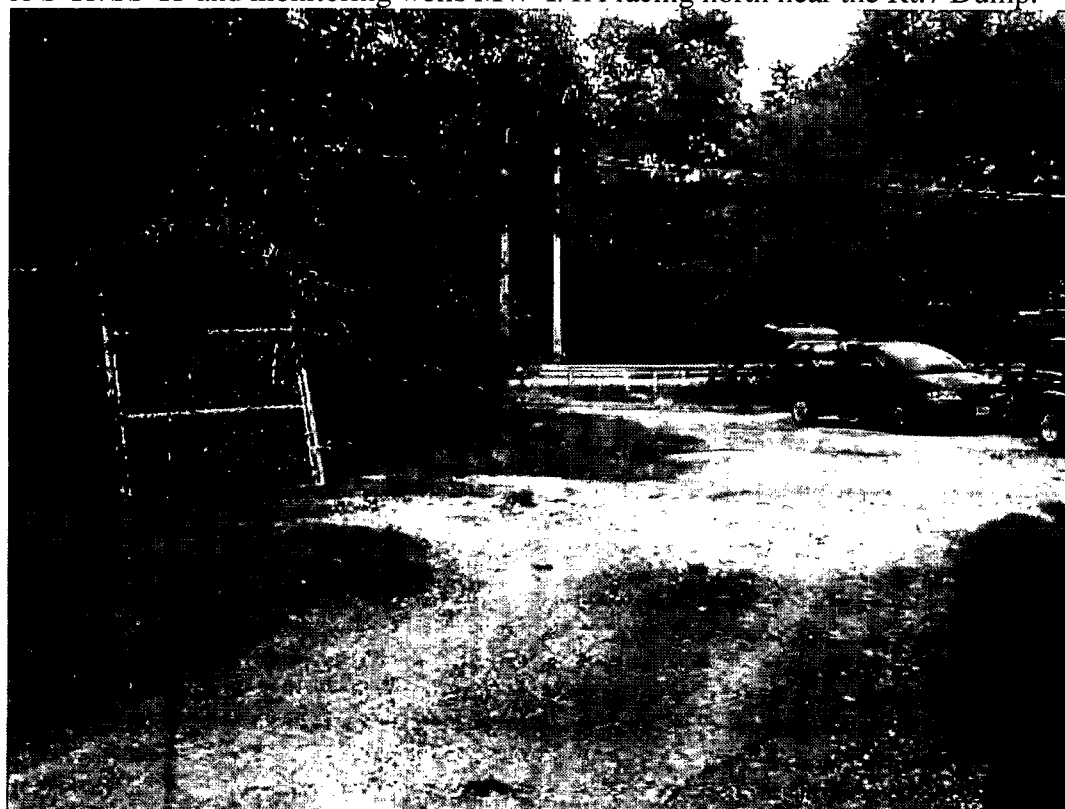
Photo of S-14/SS-14 approximately 40' south of Rt.7 collected next to the treeline.

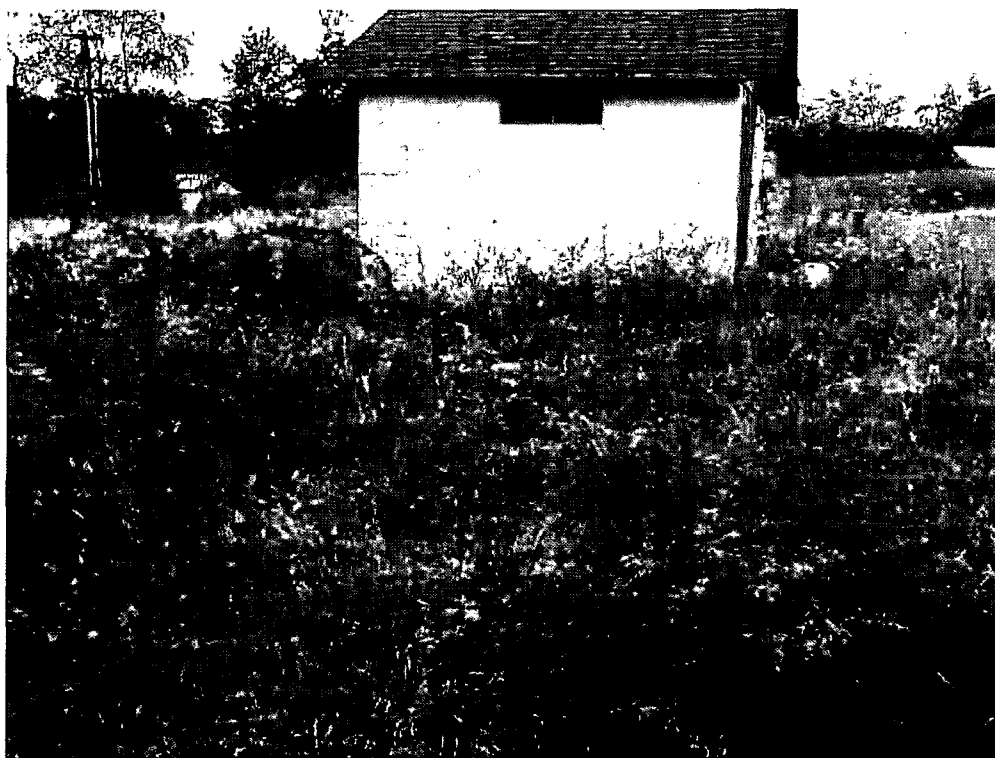
Photo of S-16, background sample collected 11' east of the production well house (PW-5).

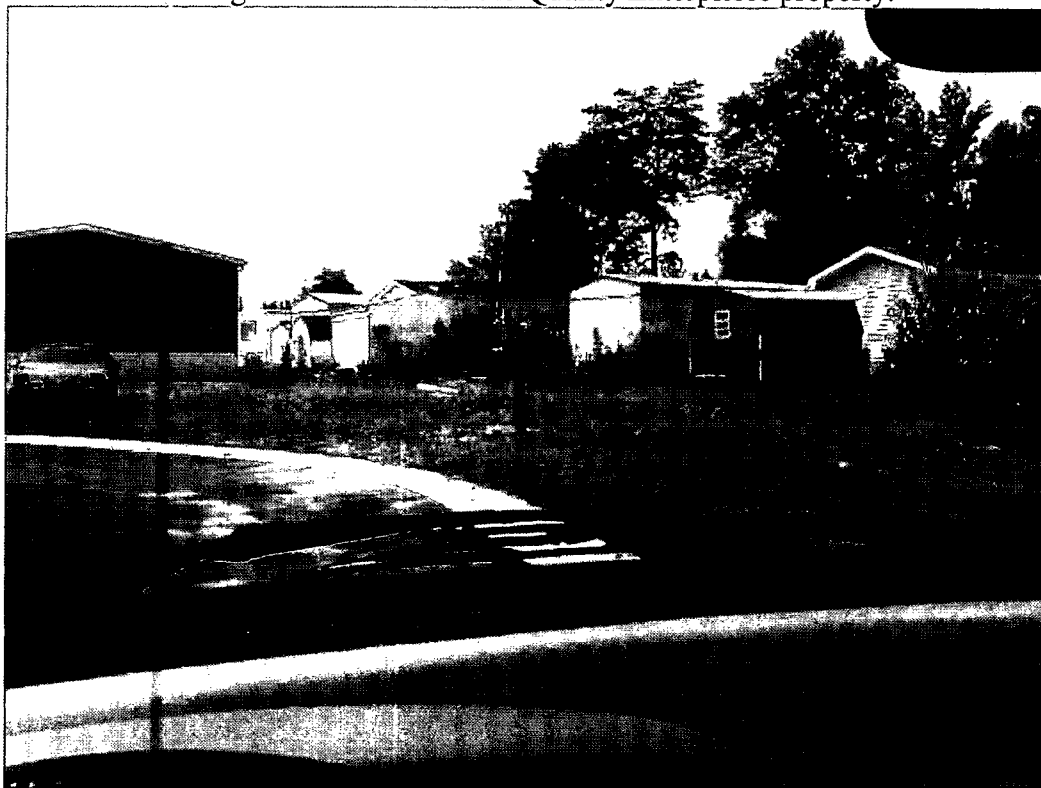
Photo of MW-4 located in the Sherwood Forest Mobile Home Park, facing south.

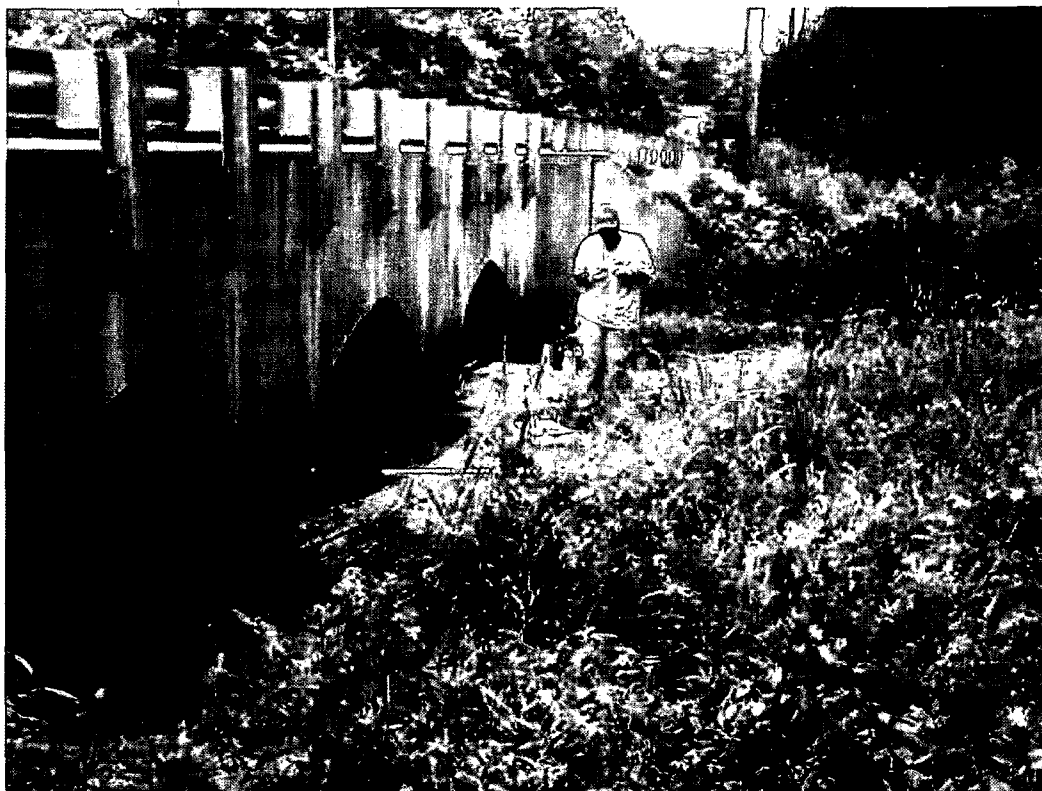
Photo of SW-1/SED-1 immediately upstream from the bridge across Rt.7, facing west.
